STAPLETON INTERNATIONAL
AIRPORT

★
GROUND WATER
MONITORING

★
SOUTHERN TIER OF
ROCKY MOUNTAIN ARSENAL

February 1987

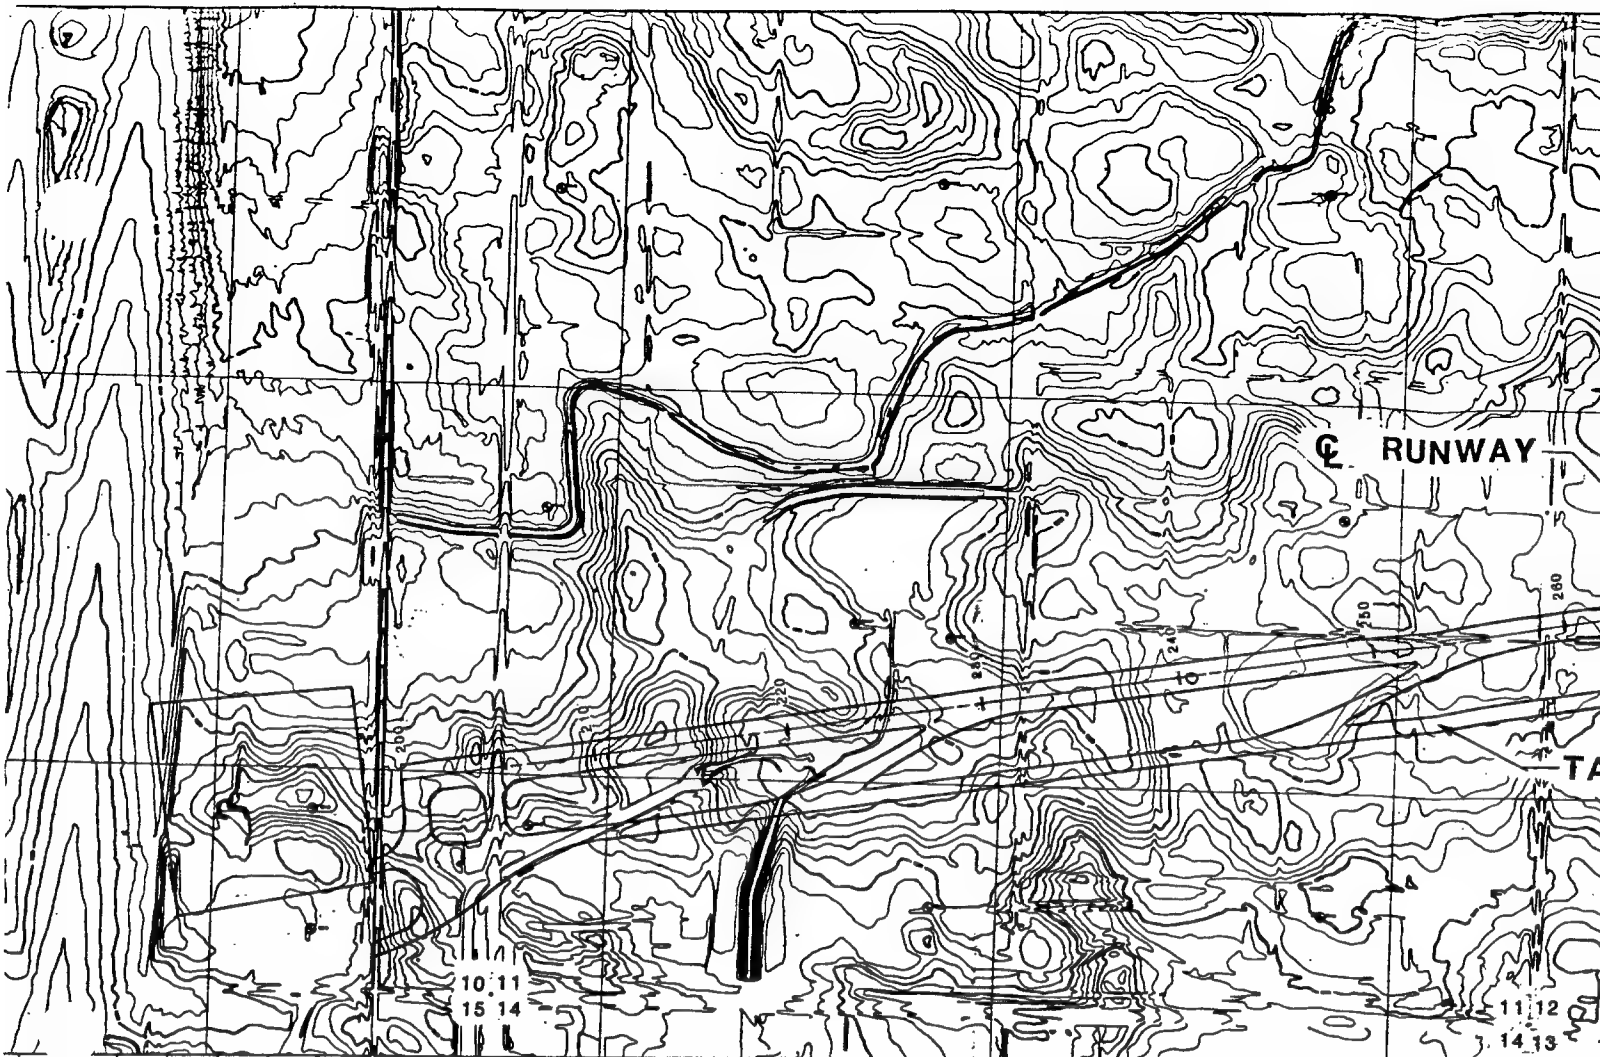
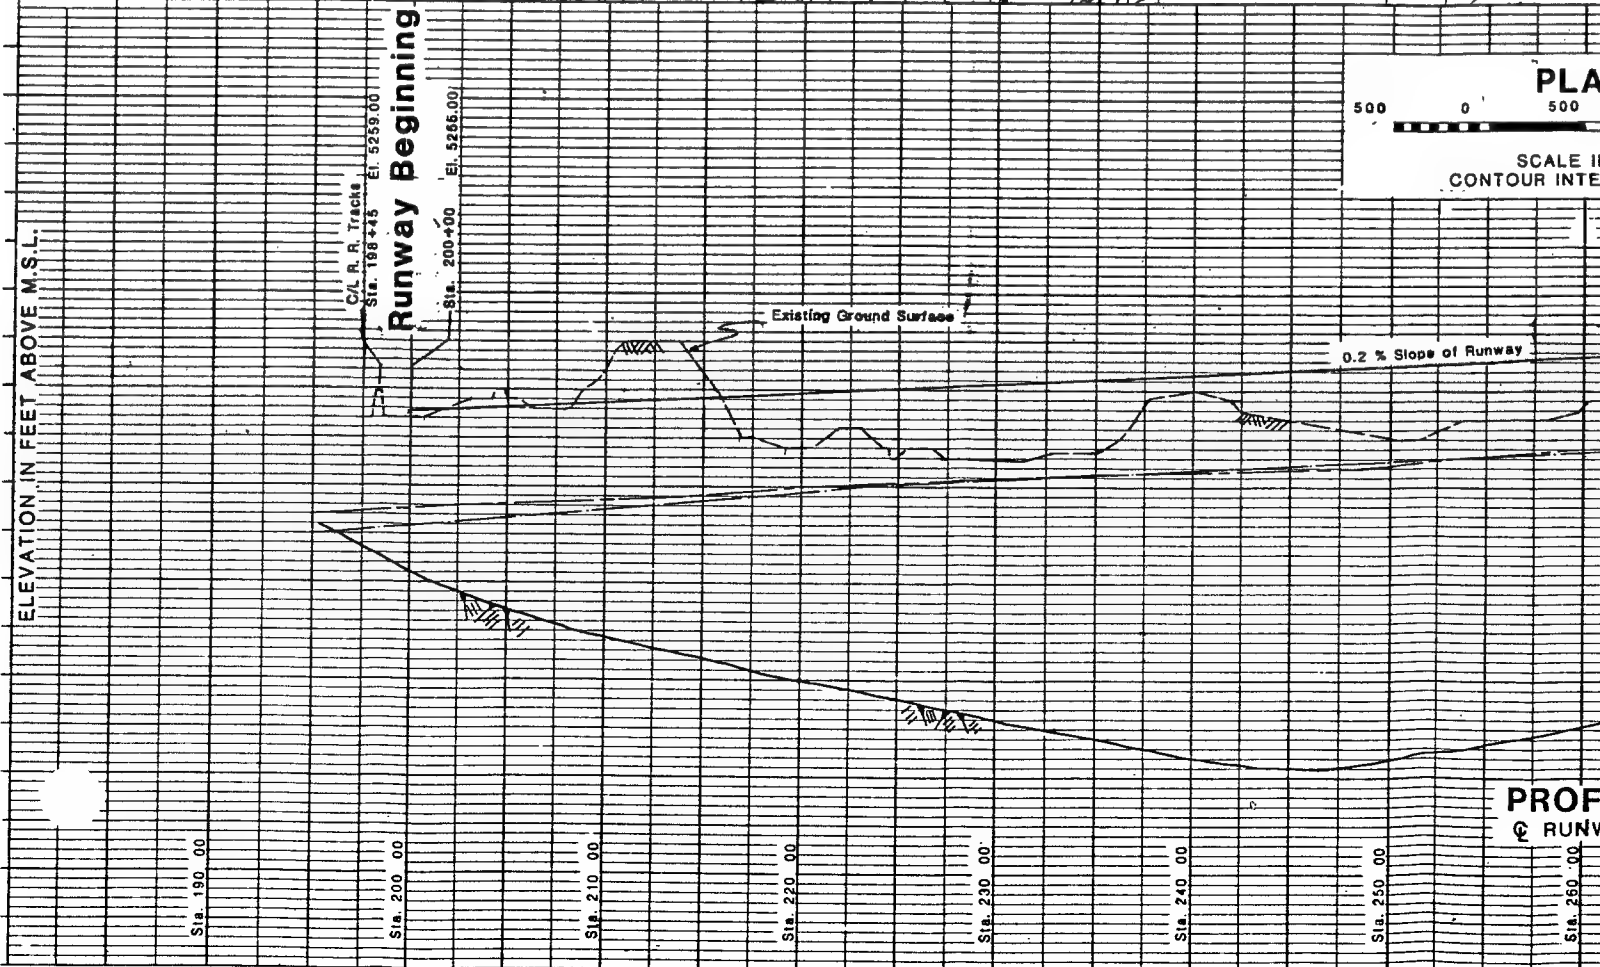
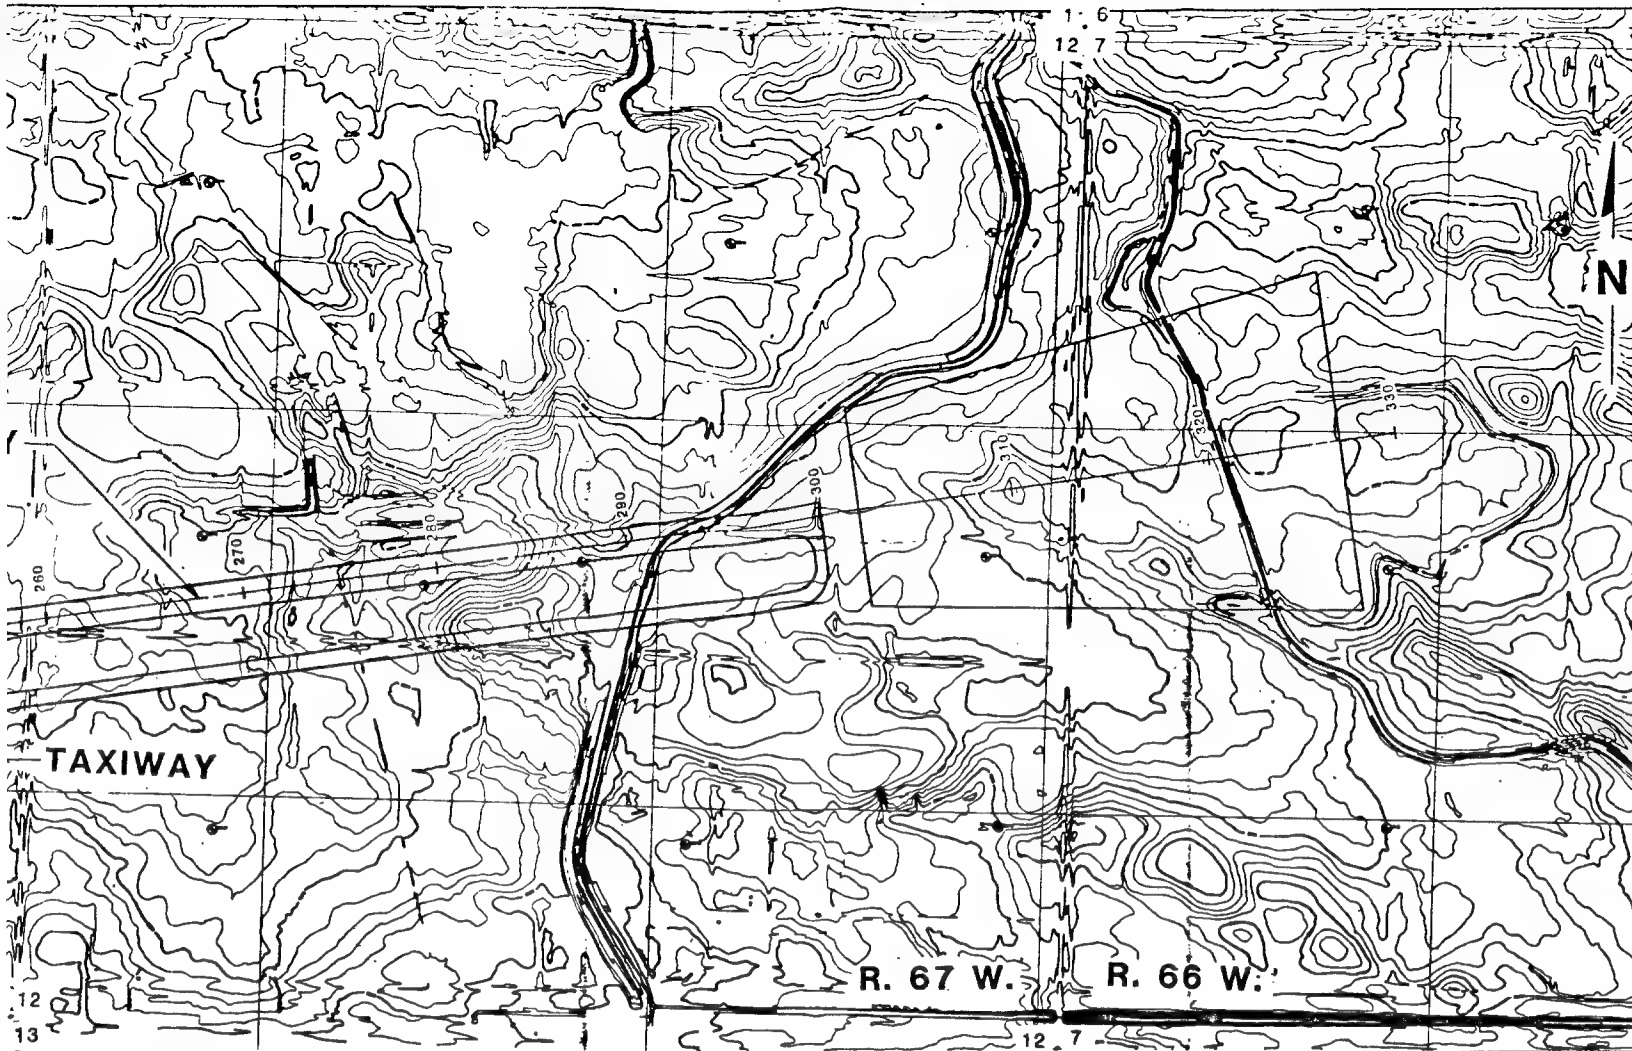
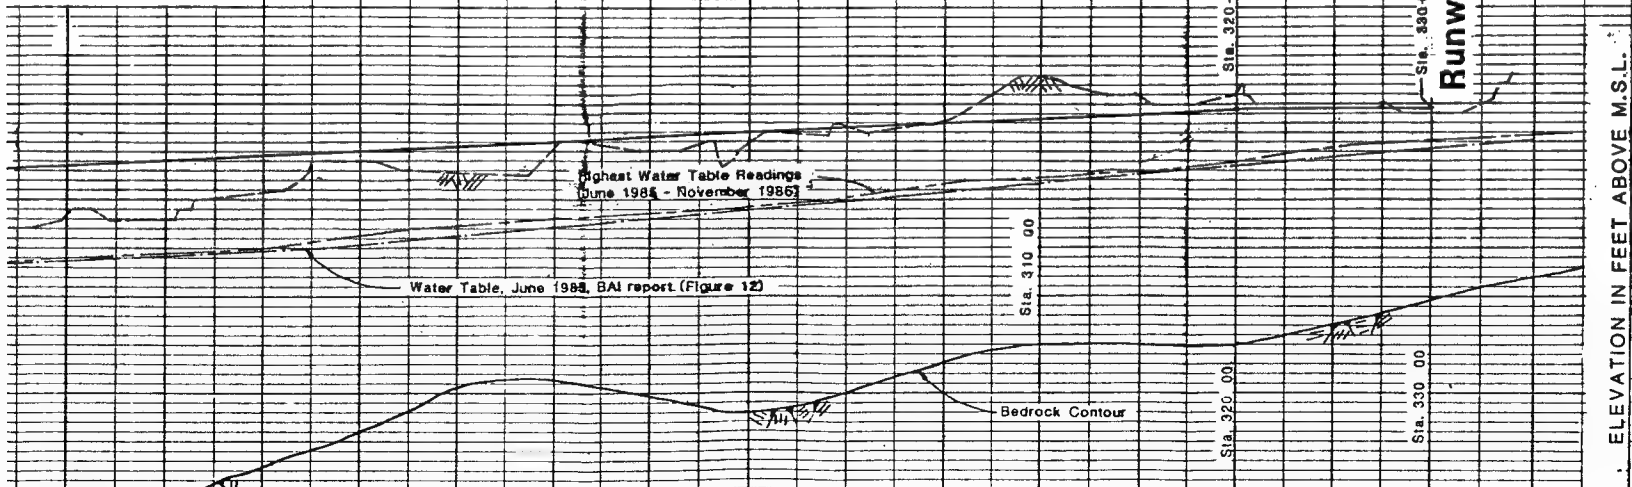
GROUNDWATER/BEDROCK PROFILE **EAST-WEST RUNWAY 9.5° CANT** STAPLETON INTERNATIONAL AIRPORT SOUTHERN TIER OF ROCKY MOUNTAIN ARSENAL

The results of the investigations are presented in profile in Figure 3 showing the initial configuration of the alluvial ground water table and bedrock beneath the selected runway alignment (9.5° Cant). This data provides the basis for the conclusions and recommendations. Figure 3 also shows the approximate location of the selected runway alignment.

(1) The water table for the East-West Runway configuration, 9.5° Cant, does not present an immediate problem from the standpoint of having to dewater for the normal runway construction. Areas of the proposed runway alignment in which the water table is nearest to the surface are in areas where the fill for the runway will be most extensive. The construction and/or operation of structures under the runway may be affected by ground water depending on where the structures are located.

The East-West Runway selected for analysis is referred to as the East-West Runway Configuration, 9.5° Cant. as established by Centennial Engineering, Inc., February 1986. The approximate location of this Configuration is shown on Figure 3. The bedrock, ground water and ground surface along the center line of the main runway was evaluated and plotted in profile as shown on Figure 3. The plot of the water table was established by measurement in June of 1985. The maximum water table plotted occurred at various times during the past year and a half of observation. The water table on June 1985 is shown in plan in Figure 12, Existing Water Table Elevation, in the report "Stapleton International Airport, Ground Water Investigation on Southern Tier of Rocky Mountain Arsenal," Blatchley Associates, Inc., January 1986. In the same report, the Bedrock Contour Map, Figure 10, was utilized in determining the profile of the bedrock under the proposed runway. An independent evaluation of the maximum water table readings in each T/M hole was reduced to a water table contour map without regard to concurrent dates amongst the T/M holes. The maximum fluctuation from the June 1985 water levels is about zero to four feet. It should be noted that the greatest fluctuation in water table occurs where the aquifer is the shallowest.

(2) It is recommended that when the field investigations for the design of the selected runway proceed, that observation holes be established only for Station 217+00 through Station 234+00 and Station 245+00 through Station 265+00. Once the water table has stabilized in the test holes, one or two readings should be sufficient to verify the water table location for construction purposes.

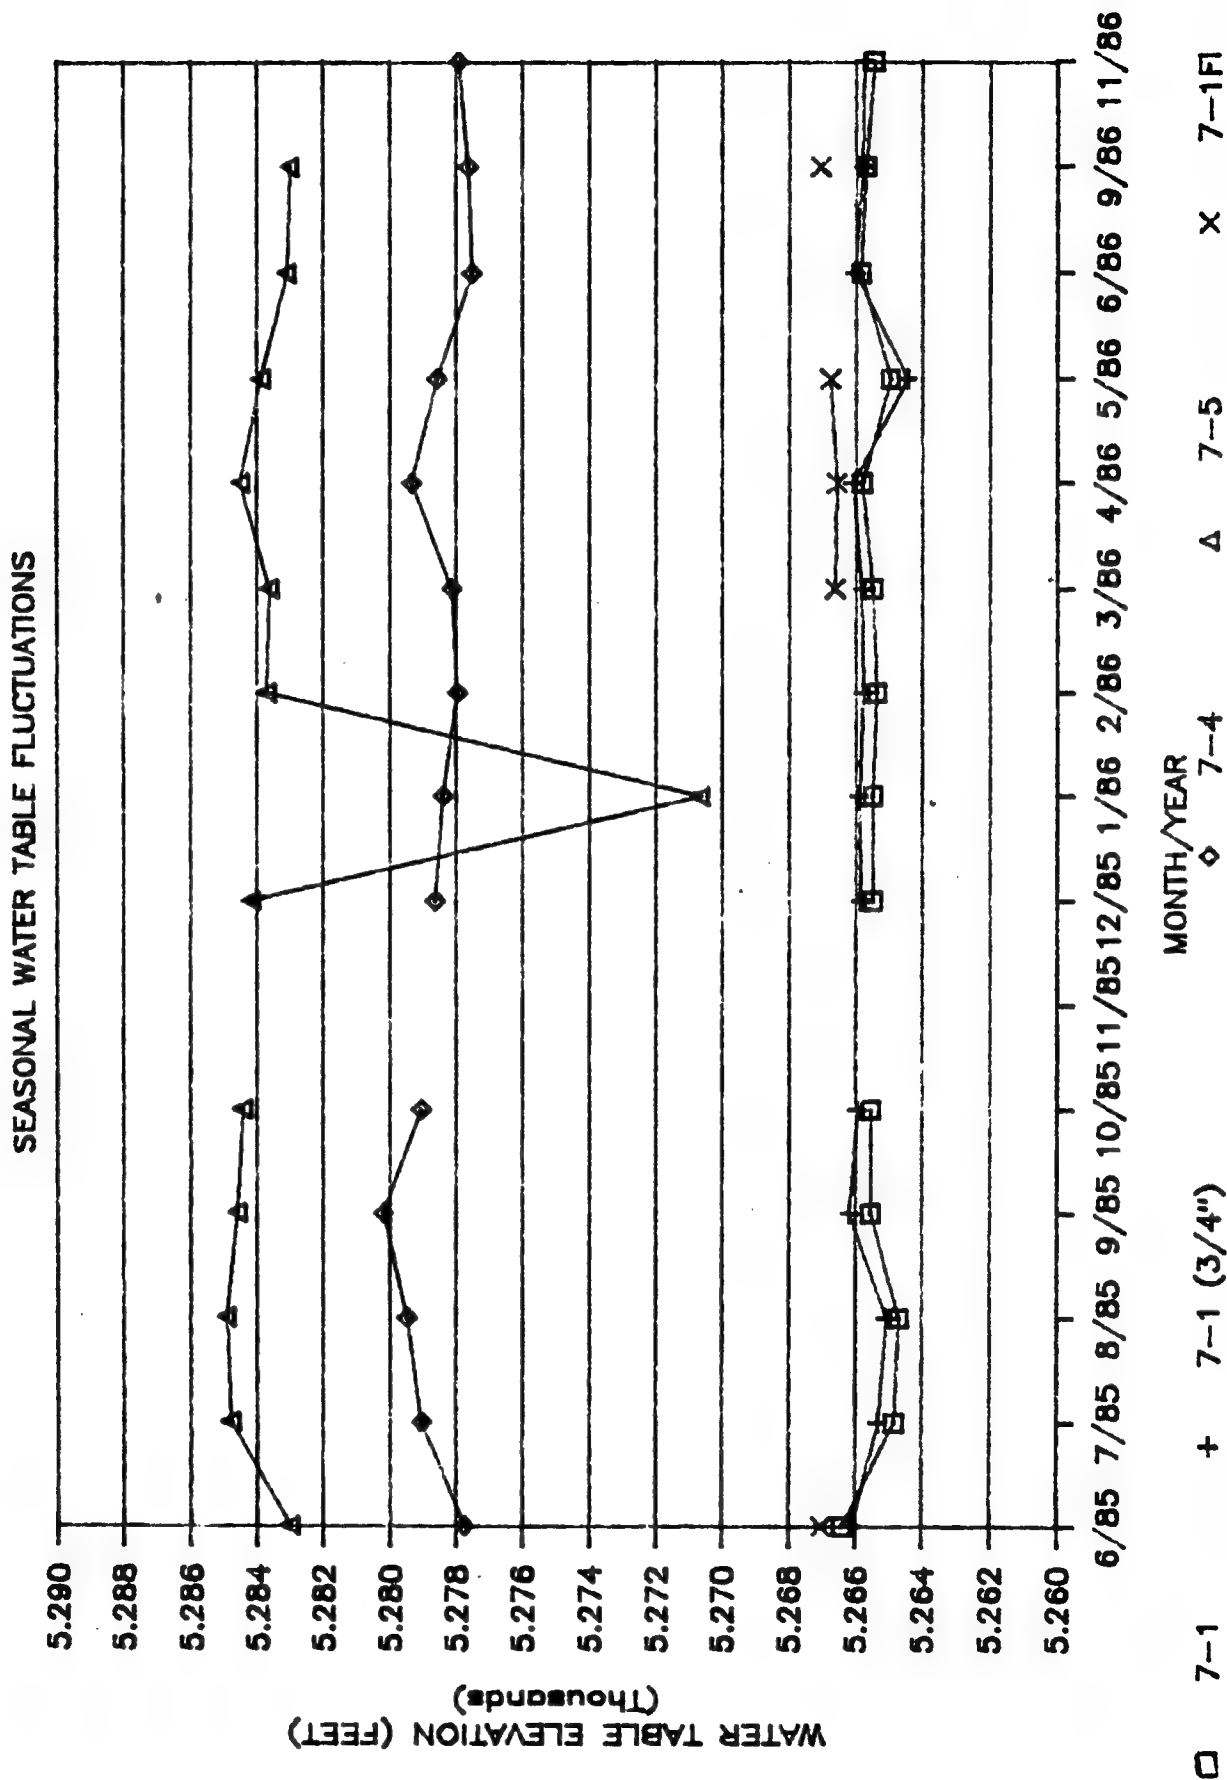
Figure 4

All data readings were considered to be good with the exception of some of the readings in January 1986. The January 1986 readings, as shown later in this report on the water table charts, were obviously in error. The cause of the readings being in error may have been due to the malfunction of the electronic measuring device.

As shown on Figures 4 through 15, the water table fluctuations were quite minor with most fluctuations less than two
